DRAFT
NONAQUEOUS PHASE LIQUID EVALUATION
REMEDIAL INVESTIGATION/FEASIBILITY STUDY, NEWTOWN CREEK

Anchor QEA, LLC

November 2016

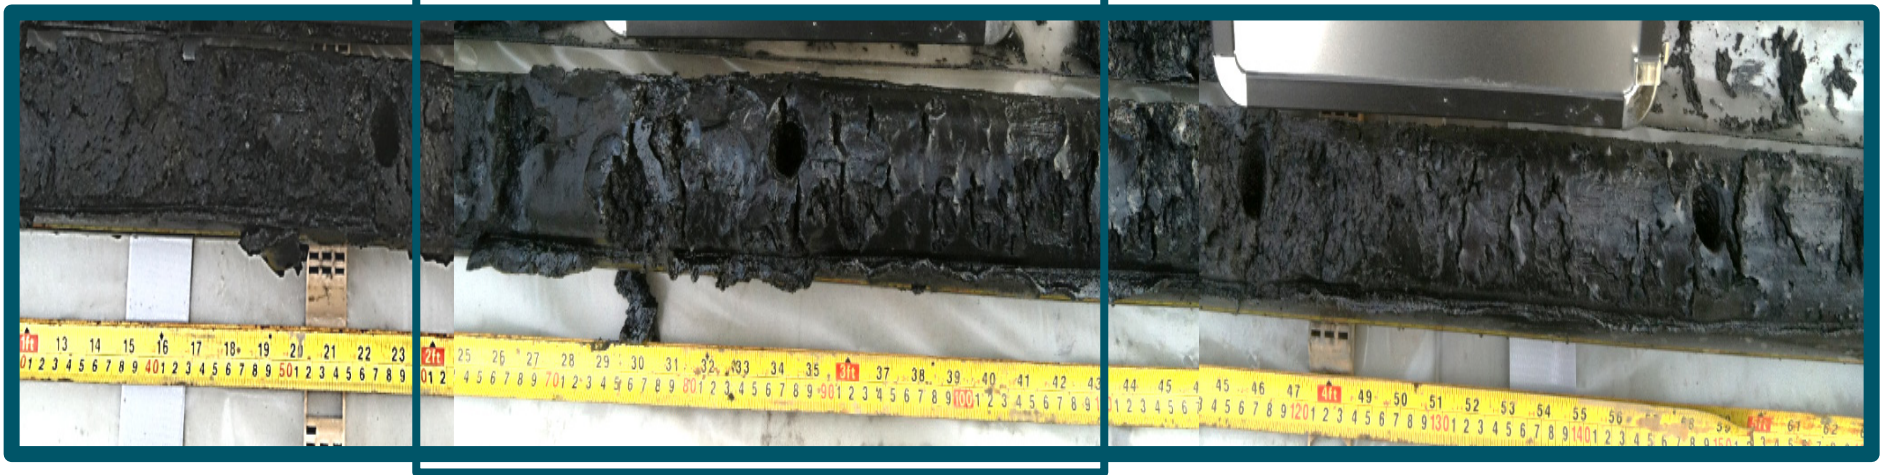
NC276SC-A Phase 2 Core: Visual observation of blebs (60 to 110 centimeters below mudline); shake test bleb rank 3 (80 centimeters below mudline)

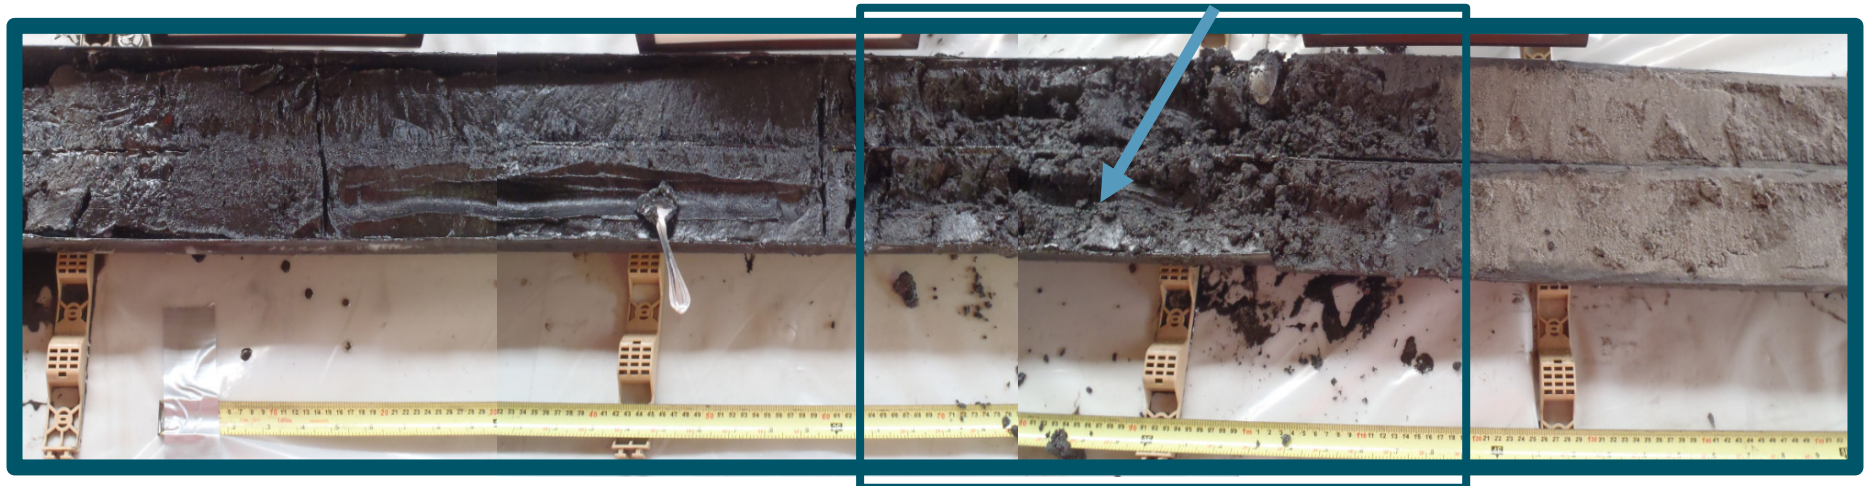
NC045BSC Phase 1 USEPA-Identified Core: Oil-stained visual observation (63 to 119 centimeters below mudline); adjacent to USEPA-identified potential upland NAPL site
